The Analysis of the Danube Floods 2006

International
Commission
for the Protection
of the Danube River

An in depth analysis of the floods
on the Danube and its main tributaries in 2006

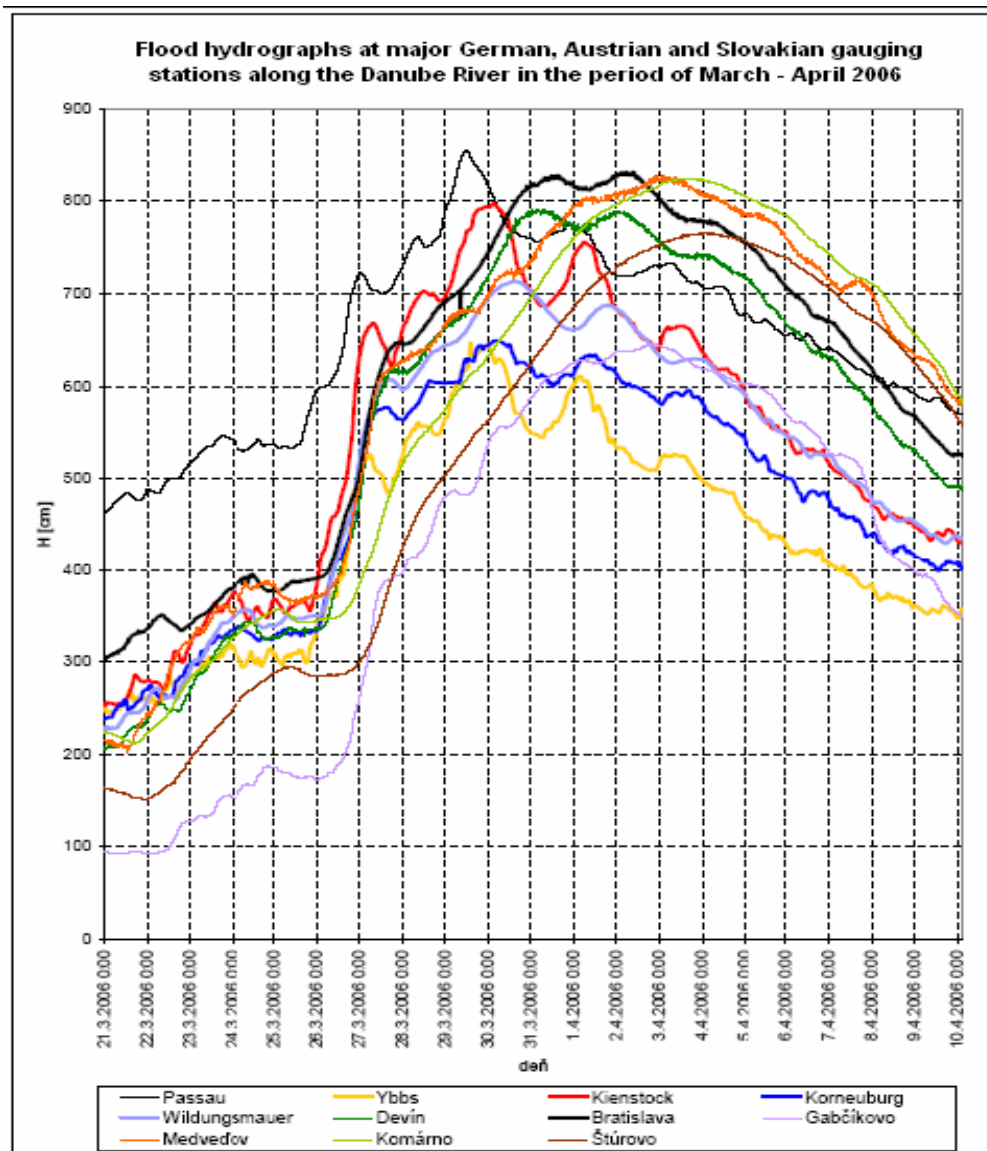
Figure c: The progression of changing water levels in the Upper Danube

Such runoff events represent a typical spring flood. However, this flood event was significant with regard to its discharge hydrograph and volume. While in the German and Austrian stretches of the Danube River the flood hydrograph had two well-marked peaks, this was not so evident on the Slovak stretch. This was the result of the influence of the Danube's left side tributary, the Morava River, in the Devín profile at the Austrian-Slovak border (river kilometre 1879). The critical flood flow proceeded slowly downstream the Danube with specific time delays from Passau (km 2225) to Sturovo/Estergom (km 1719) on a stretch of approximately 500 km.

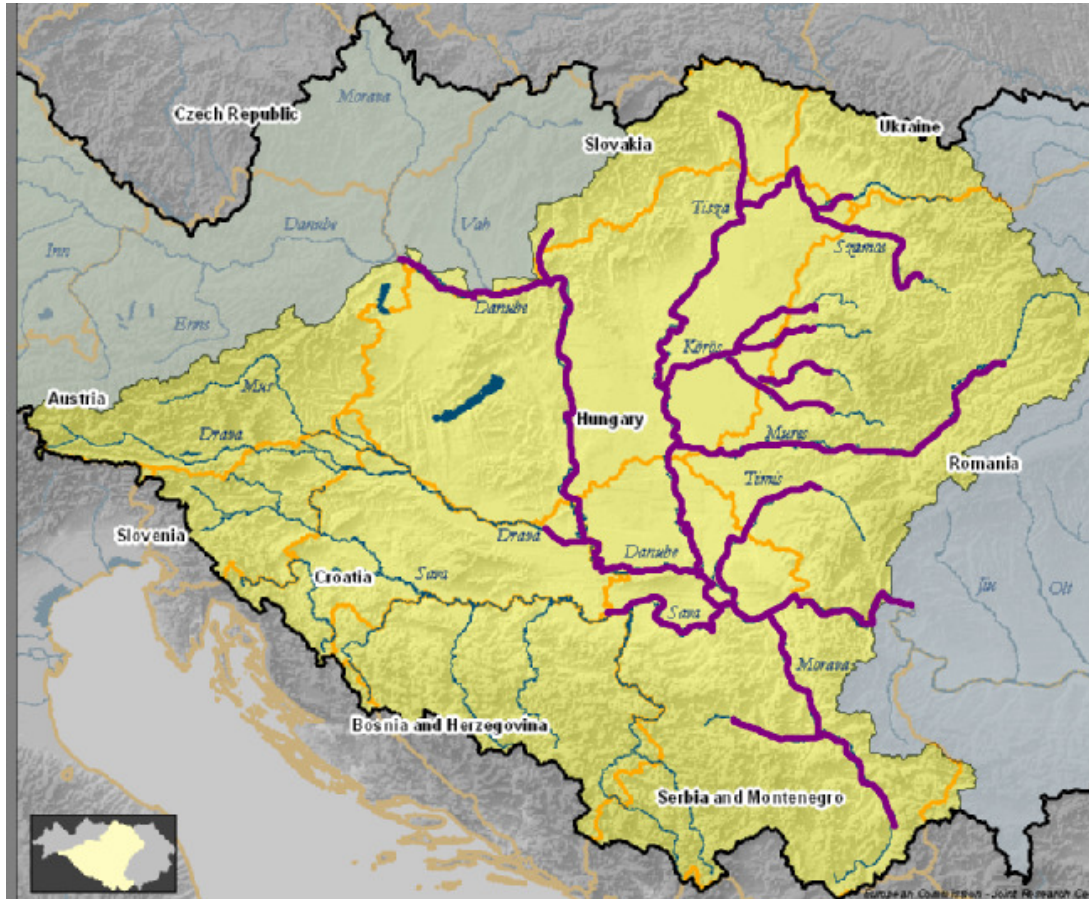
Figure d: Rivers affected by significant flooding in the Central Danube Basin (violet)

the multi-annual average by 70 %) and in the Körös/Crisul river system (where levels were exceeded by 30 %).

The combination of heavy precipitation and the snow melt resulted in an exceptional runoff.

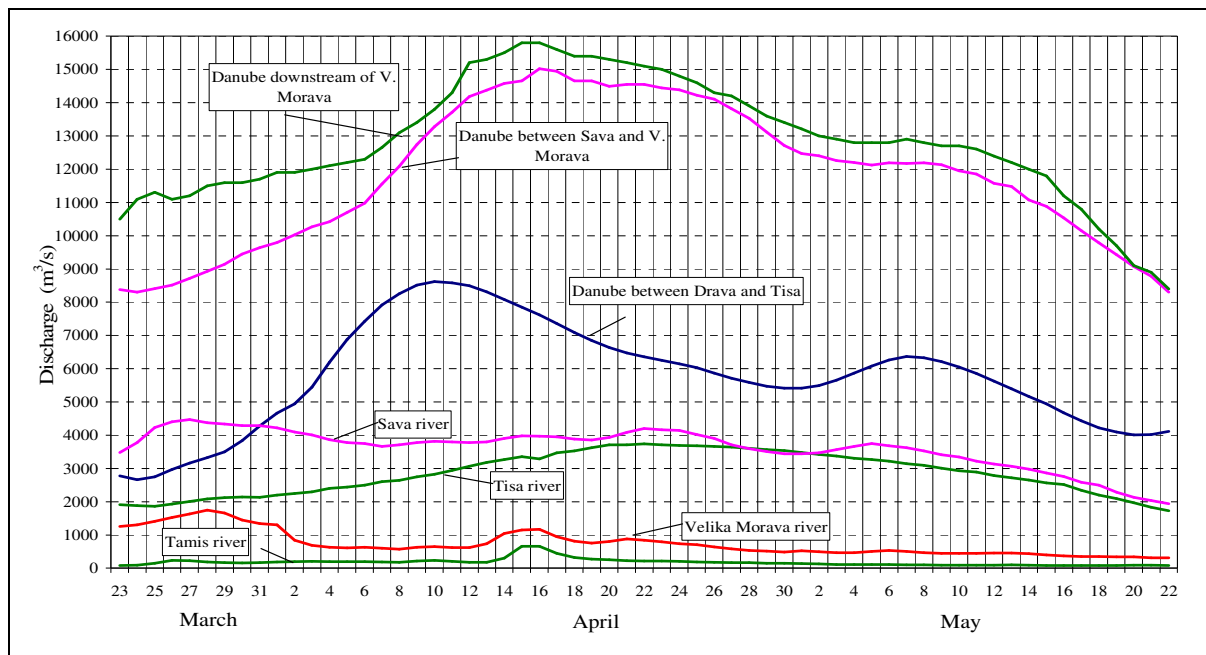
Figure e: Hydrographs of the Danube, Tisa, Sava, Velika Morava and Tamis (23.03. – 22.05.06)

The flooding on the Sava River lasted an unusually long period, beginning in mid March and lasting until mid May. During this time the river flow was always between 3000 m³/s and 4000 m³/s (a return period of 1-5 years). In this way, the rare coincidence of relatively large and prolonged floods on all the main tributaries of the Central Danube Basin resulted in one of the largest floods recorded in the lower Danube stretch.

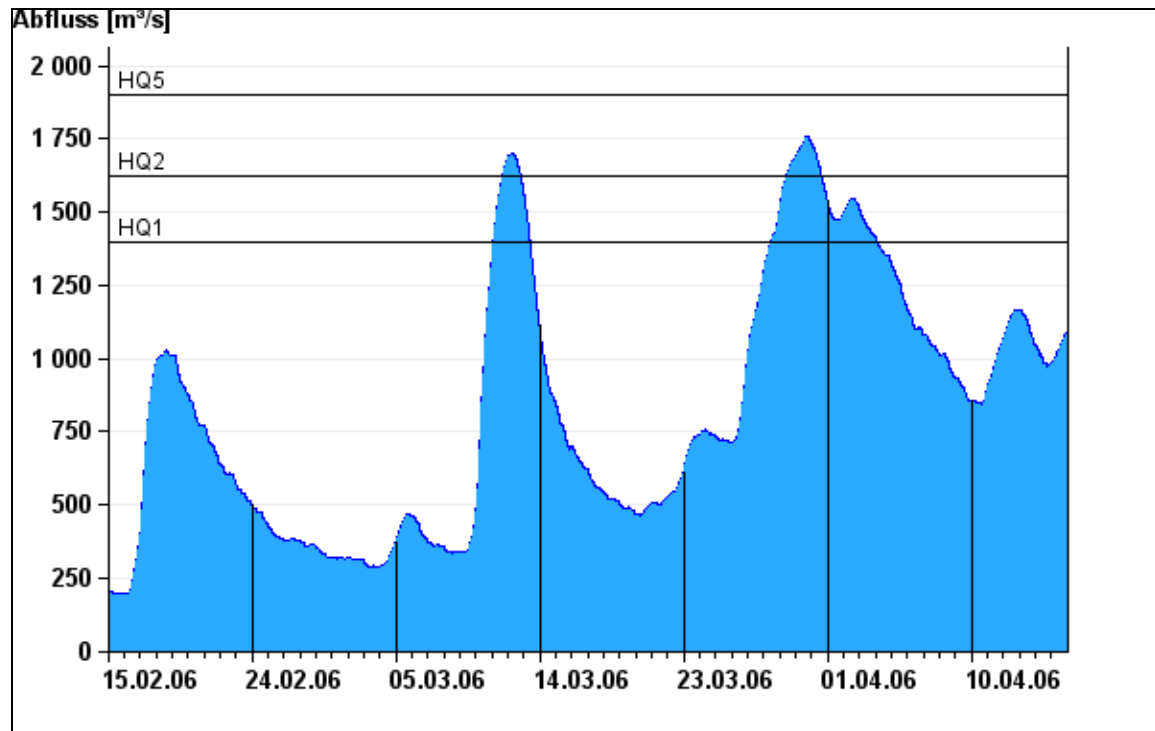
Figure 11: Hydrograph of the Danube River at Pfelling

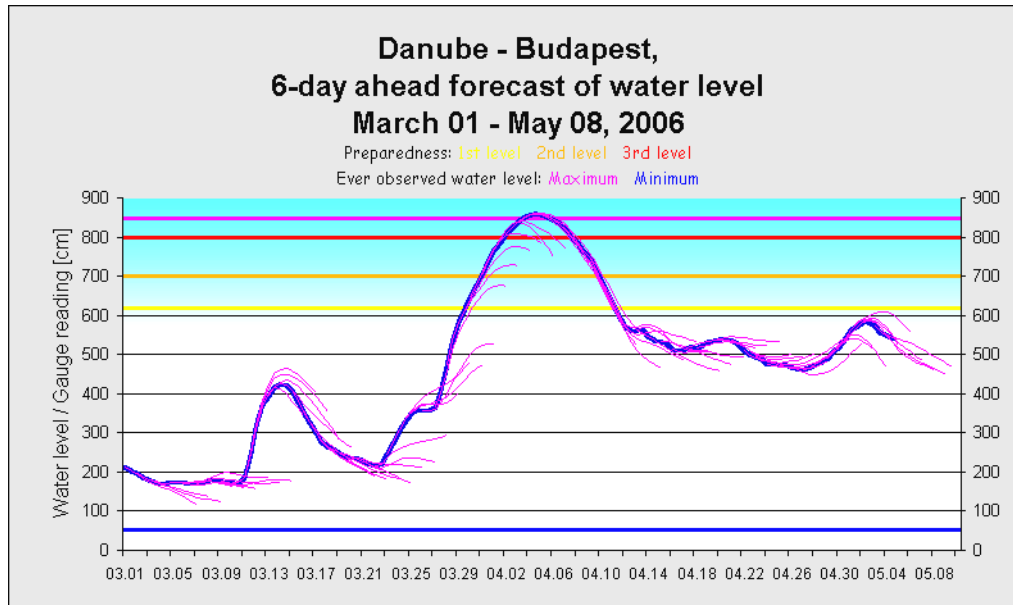
meant a valuable contribution was made to forecasting the flood wave in, and downstream of, the Danube Bend and Budapest. This underestimation and ongoing deficiencies in the calibration of the hydrodynamic part of the LISFLOOD model (resulting in underestimating the impact of the backwater effect), in turn resulted in an underestimation of, and an earlier prediction of the timing of, peaks within the Tisza system.

Figure 18: Danube – Budapest 6-day forecast
