# Floods in June 2013 in the Danube River Basin

**icpdr** **iksd**

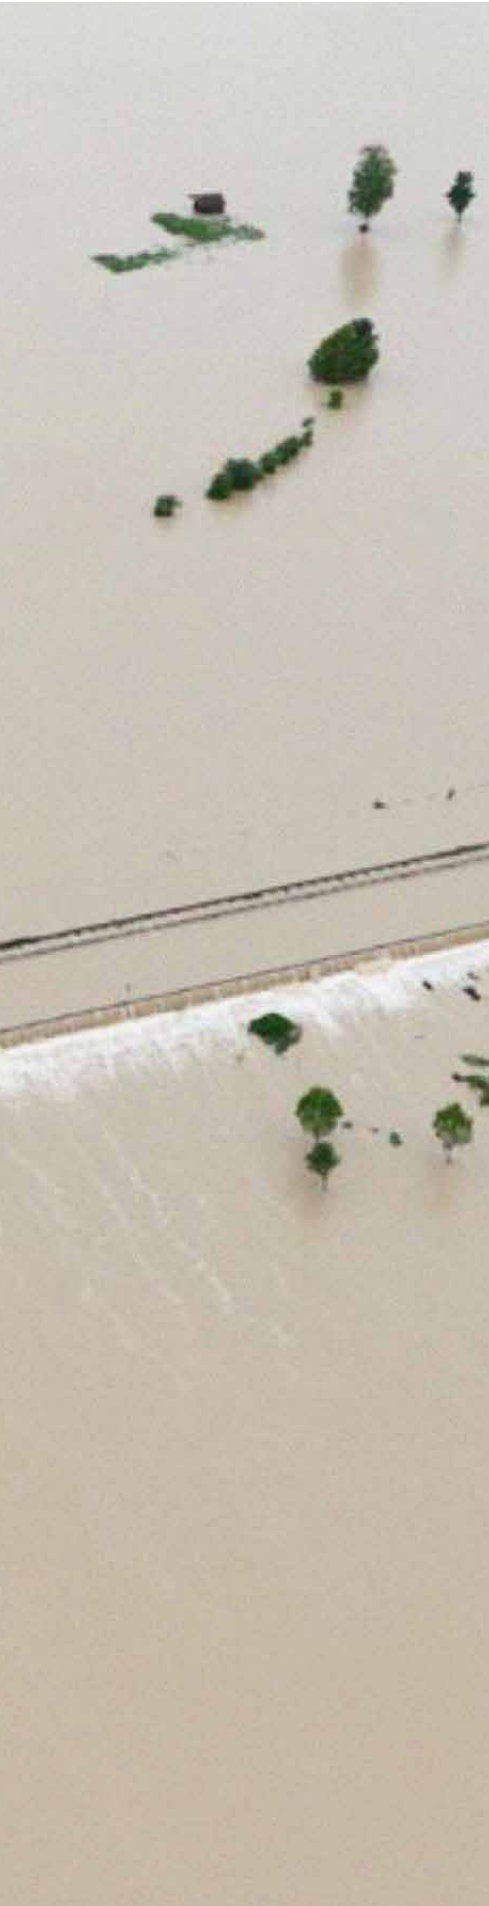
<b>1.</b>	<b>INTRODUCTION</b>	<b>5</b>
<b>2.</b>	<b>METEOROLOGICAL SITUATION/PRECIPITATION</b>	<b>6</b>
2.1	Upper Danube	6
2.2	Lower Danube	8
<b>3.</b>	<b>KEY FLOOD EVENTS</b>	<b>9</b>
3.1	Germany	9
3.2	Austria	9
3.3	Slovakia	9
3.4	Hungary	11
3.5	Croatia	12
3.6	Serbia	13
3.7	Romania	13
3.8	Bulgaria	13
<b>4.</b>	<b>FLOOD WARNING AND MONITORING</b>	<b>14</b>
4.1	National systems	14
4.1.1	Germany	14
4.1.2	Austria	14
4.1.3	Slovakia	14
4.1.4	Hungary	15
4.1.5	Croatia	15
4.1.6	Serbia	15
4.1.7	Romania	15
4.1.8	Bulgaria	15
4.2	Danube EFAS response	16
<b>5.</b>	<b>FLOOD INTERVENTIONS AND AFFECTED AREA</b>	<b>17</b>
5.1	Germany	17
5.2	Austria	18
5.3	Slovakia	18
5.4	Hungary	18
5.5	Croatia	20
5.6	Serbia	21
5.7	Romania	21
5.8	Bulgaria	21

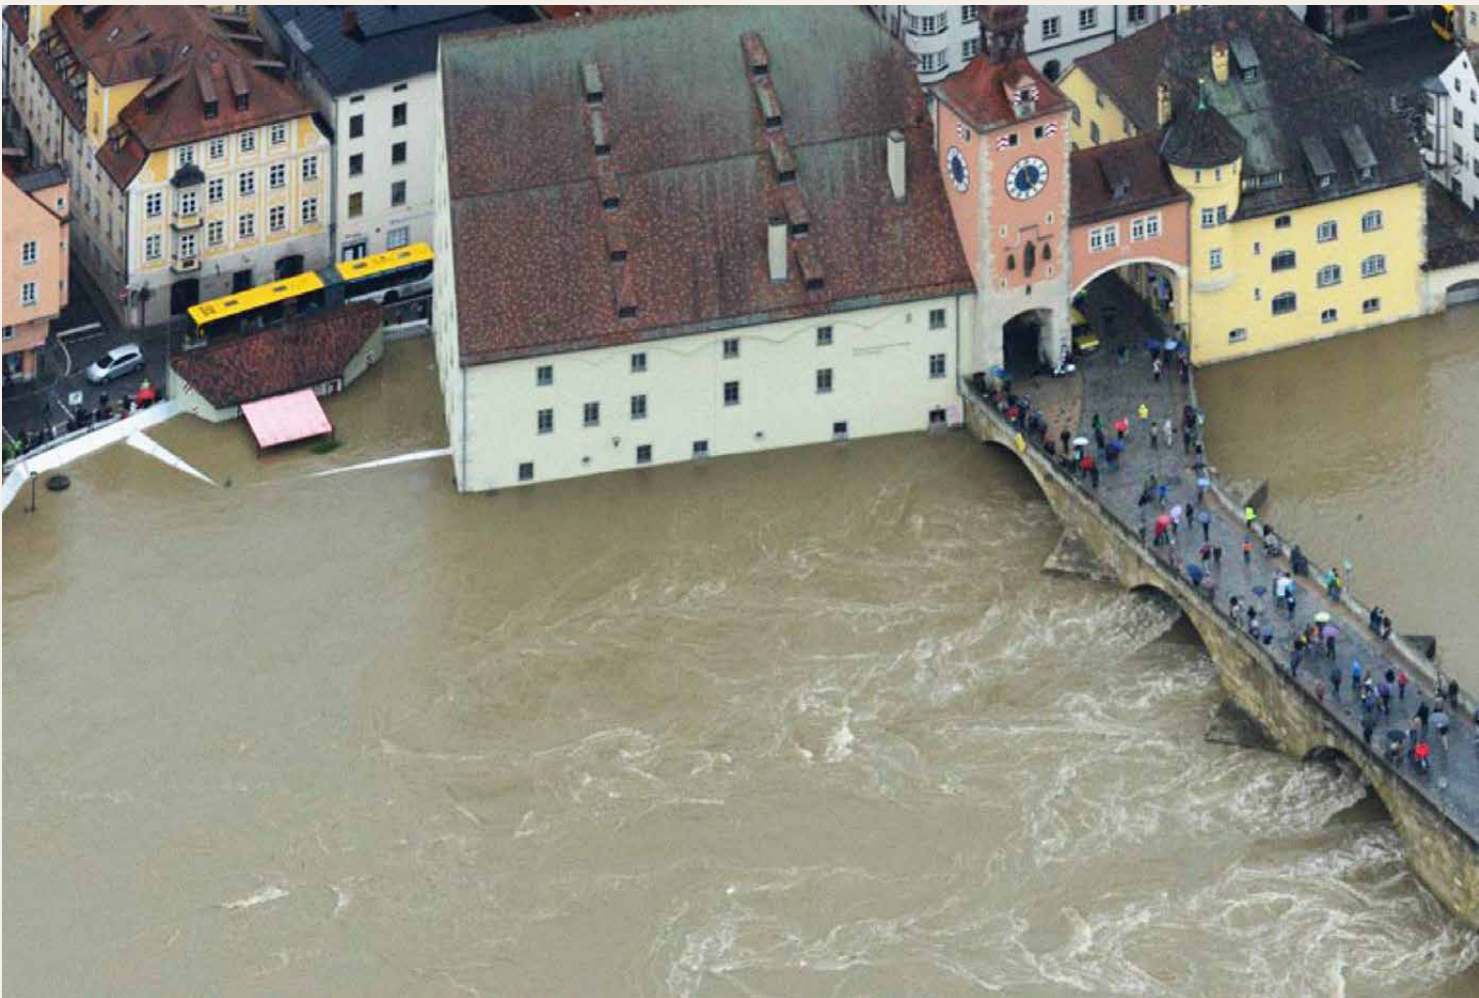
## 2. Meteorological situation/ precipitation

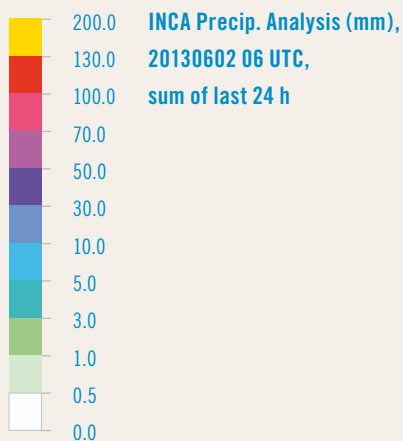
During six days of constant precipitation (30.05.–03.06.2013) along the Northern Alps from Bavaria to the Czech Republic a substantial flood event occurred. In total more than 400 mm of precipitation had been measured which is about the half-year sum, whereas these sums met mainly moist to saturated conditions due to intense rainfalls prior to the event. The individual daily precipitation sums were not exceptionally high. It was the accumulation over the four days from the 30<sup>th</sup> of May to the 2<sup>nd</sup> of June that ultimately resulted in extreme flooding.

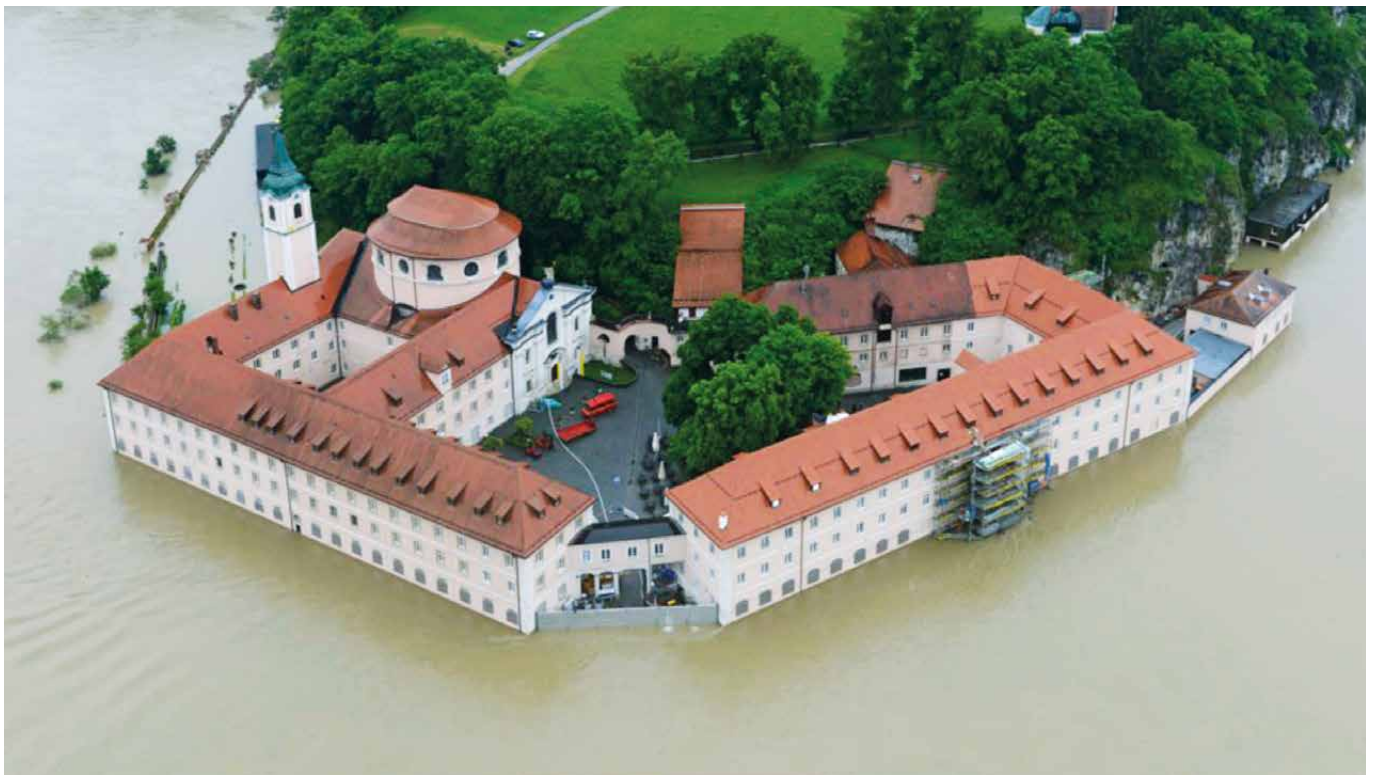
## 7.1 Land Use and Spatial Planning

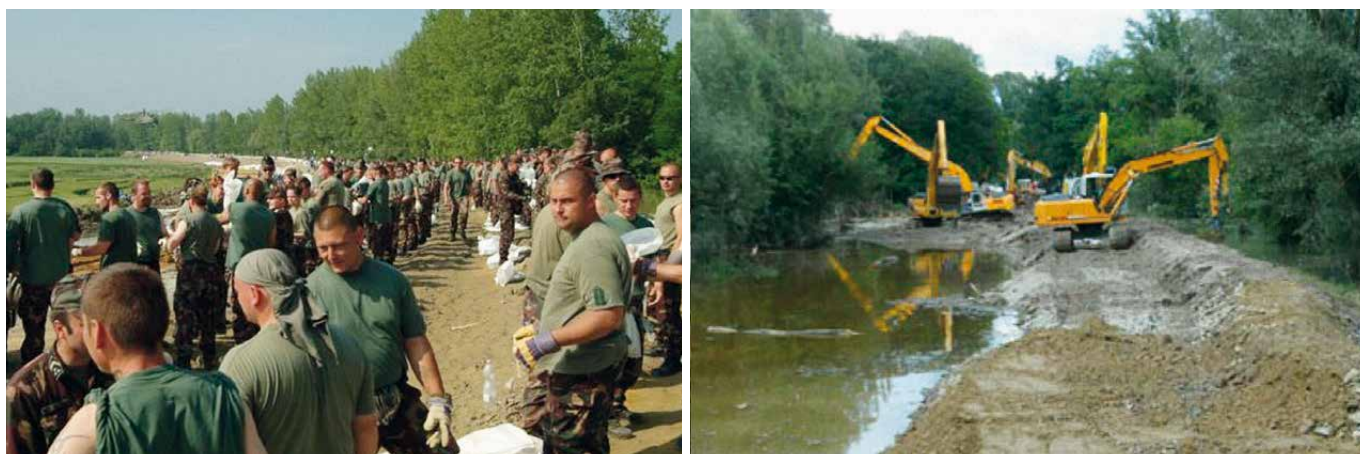
In Hungary it became obvious in the beginning of the flood that the settlements (authorities) were not prepared for handling such emergency situations and that the available defense plans have serious deficiencies. The update of these plans was needed and it is being carried out with a financial support by the government. An appropriate training programme for municipalities and stakeholders has to be organized.
