Floods in Summer 2023 in the Danube River Basin

Brief Overview of Key Events and Lessons Learned

Document No. / Version: Final

Date: 30 October 2025

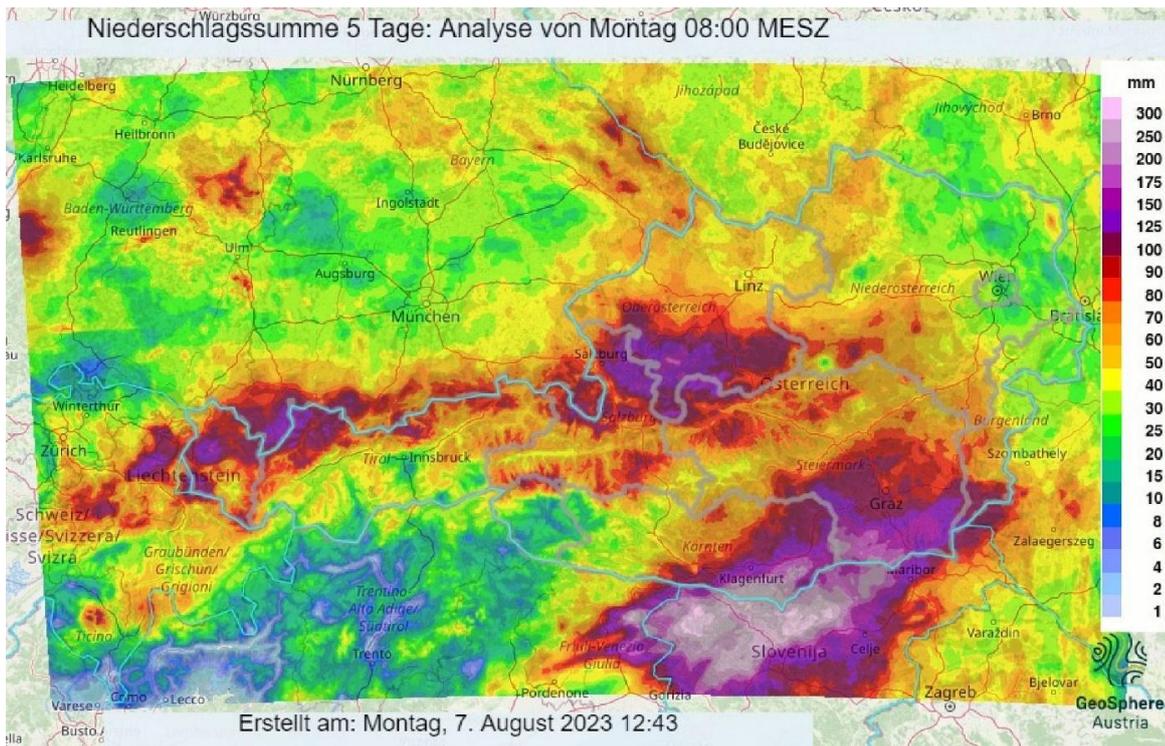
Figure 1: Accumulated precipitation total from Thursday, 3.8.2023 08:00 to Monday, 7.8.2023 08:00. Source: Geosphere Austria.

Figure 1). Carinthia, southern Styria and southern Burgenland were particularly affected, but there was also heavy rainfall in the Salzkammergut and Vorarlberg.

By 8 AM on 4th August, over 200 mm of rainfall had been measured at certain gauging stations within 24 hours, and almost everywhere from Upper Soča Valley and the Idrija region towards the east-northeast, including the Drava Valley, over 100 mm of rainfall (Figure 1). In most part of Styria and Prekmurje region, the rainfall was smaller, with less than 30 mm in areas near the Croatian border. Very little or no rain was observed from Slovenian Istria and Karst through most of the southern half of Slovenia. Heavier rainfall affected this region during the day on 4th August, and by the morning of 5th August, the heaviest rainfall, up to around 100 mm, was recorded in the southwestern part of Slovenia (Figure 2). Towards the north and east of Slovenia, the rainfall was less but still considerable, ranging from 30 to 80 mm. Rainfall began to subside on 5th August (

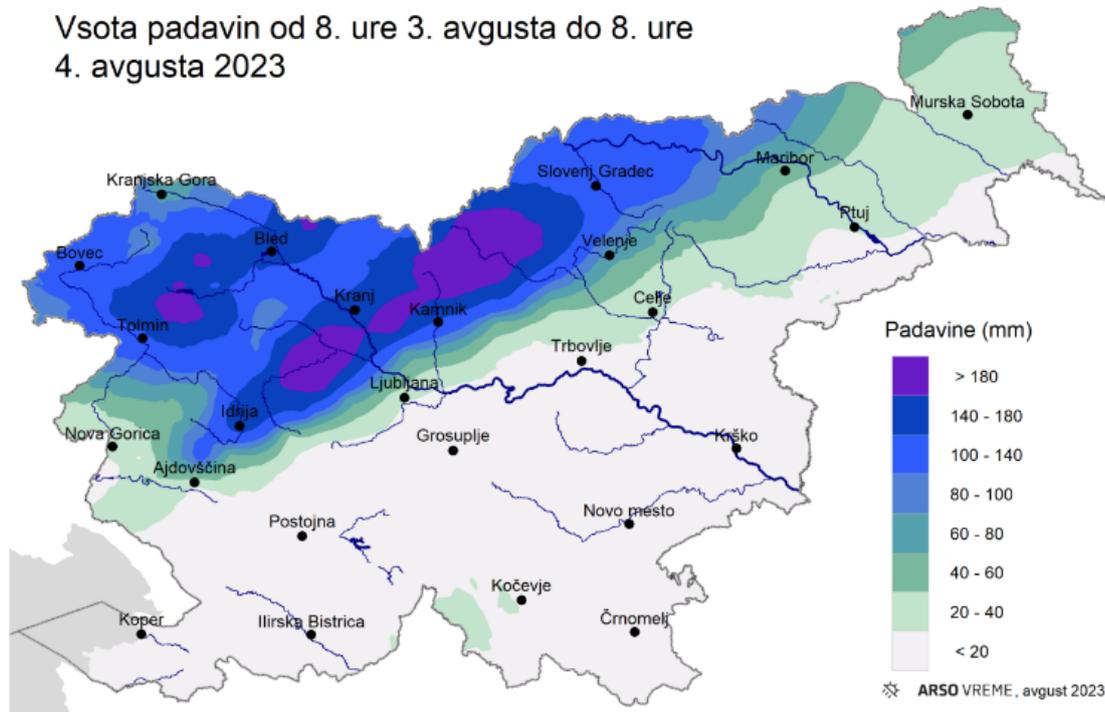
Figure 2: Map of daily (24-hour) precipitation height until 8 AM on 4.8.2023, based on measurements from gauging stations.

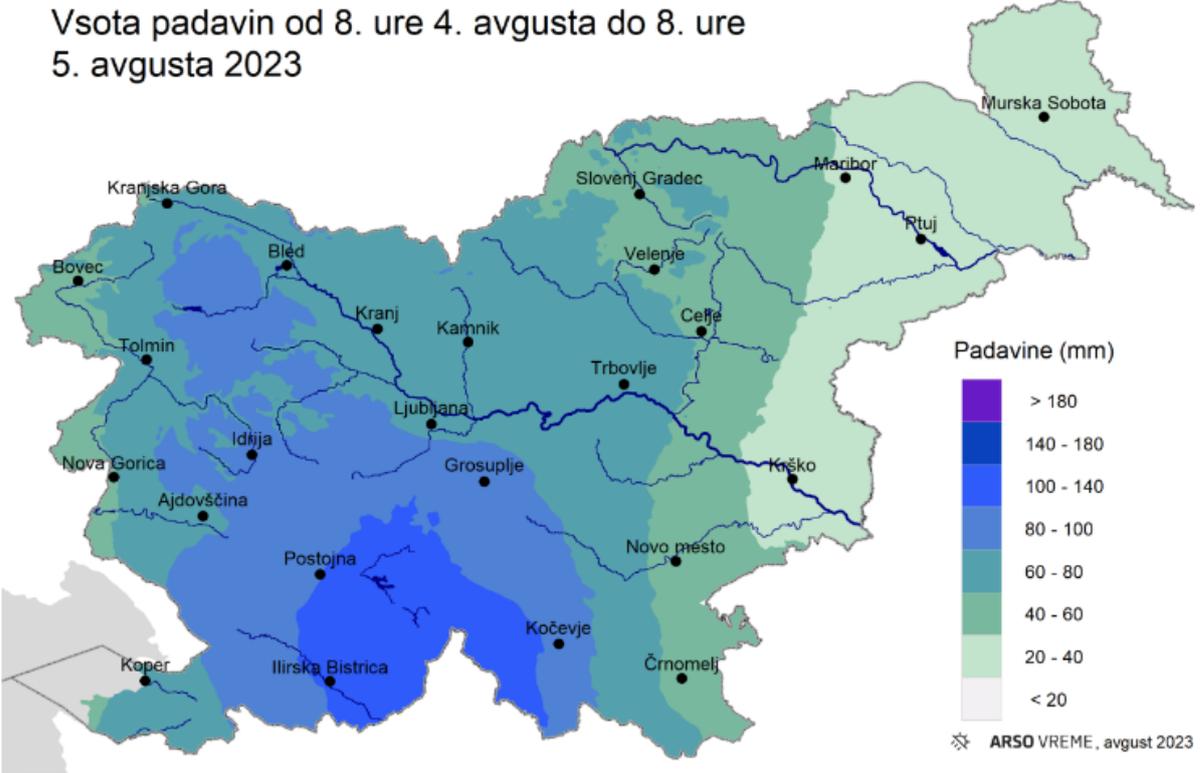
Figure 3: Map of daily (24-hour) precipitation height until 8 AM on 5.08.2023, based on measurements from gauging stations.

Figure 3), but thunderstorms in the western and southern parts of Slovenia brought additional rain on the afternoon of 6th August. In total, within 72 hours, by the morning of 6th August, between 100 and 300 mm of rain fell over most part of Slovenia, with less in parts of Primorska region and along the eastern border with Croatia (Figure 4). High water thresholds were exceeded at 122 gauging stations on 74 rivers in Slovenia¹.

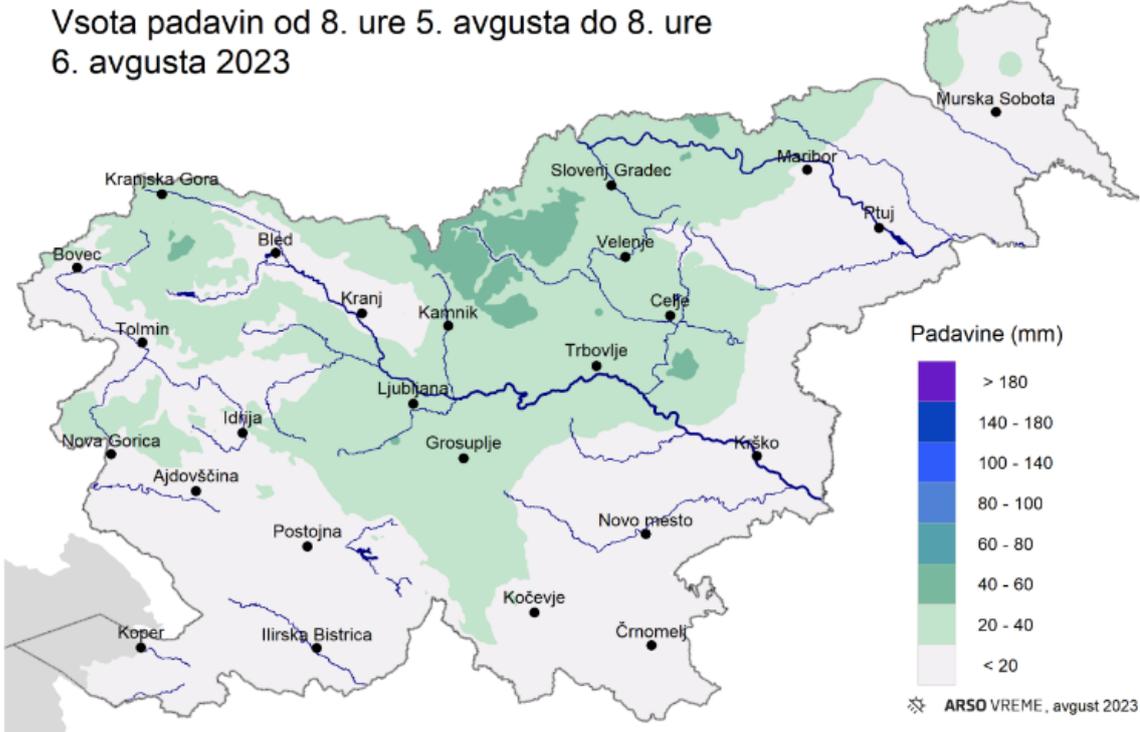
Figure 4: Map of the 24-hour precipitation height until 8 AM on 6.08.2023 based on gauging station measurements.

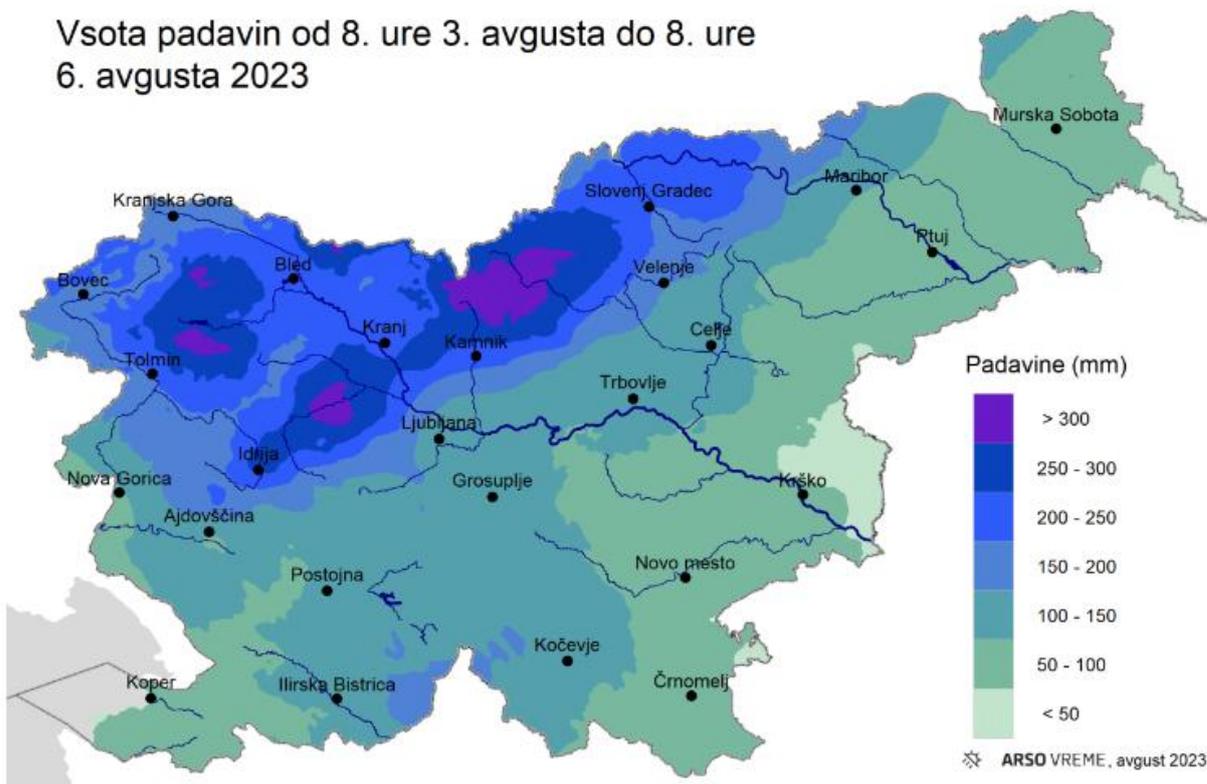
Figure 5: Map of three-day (72-hour) precipitation height from 8 AM on 3 August to 8 AM on 6.08.2023, based on measurements from gauging stations.

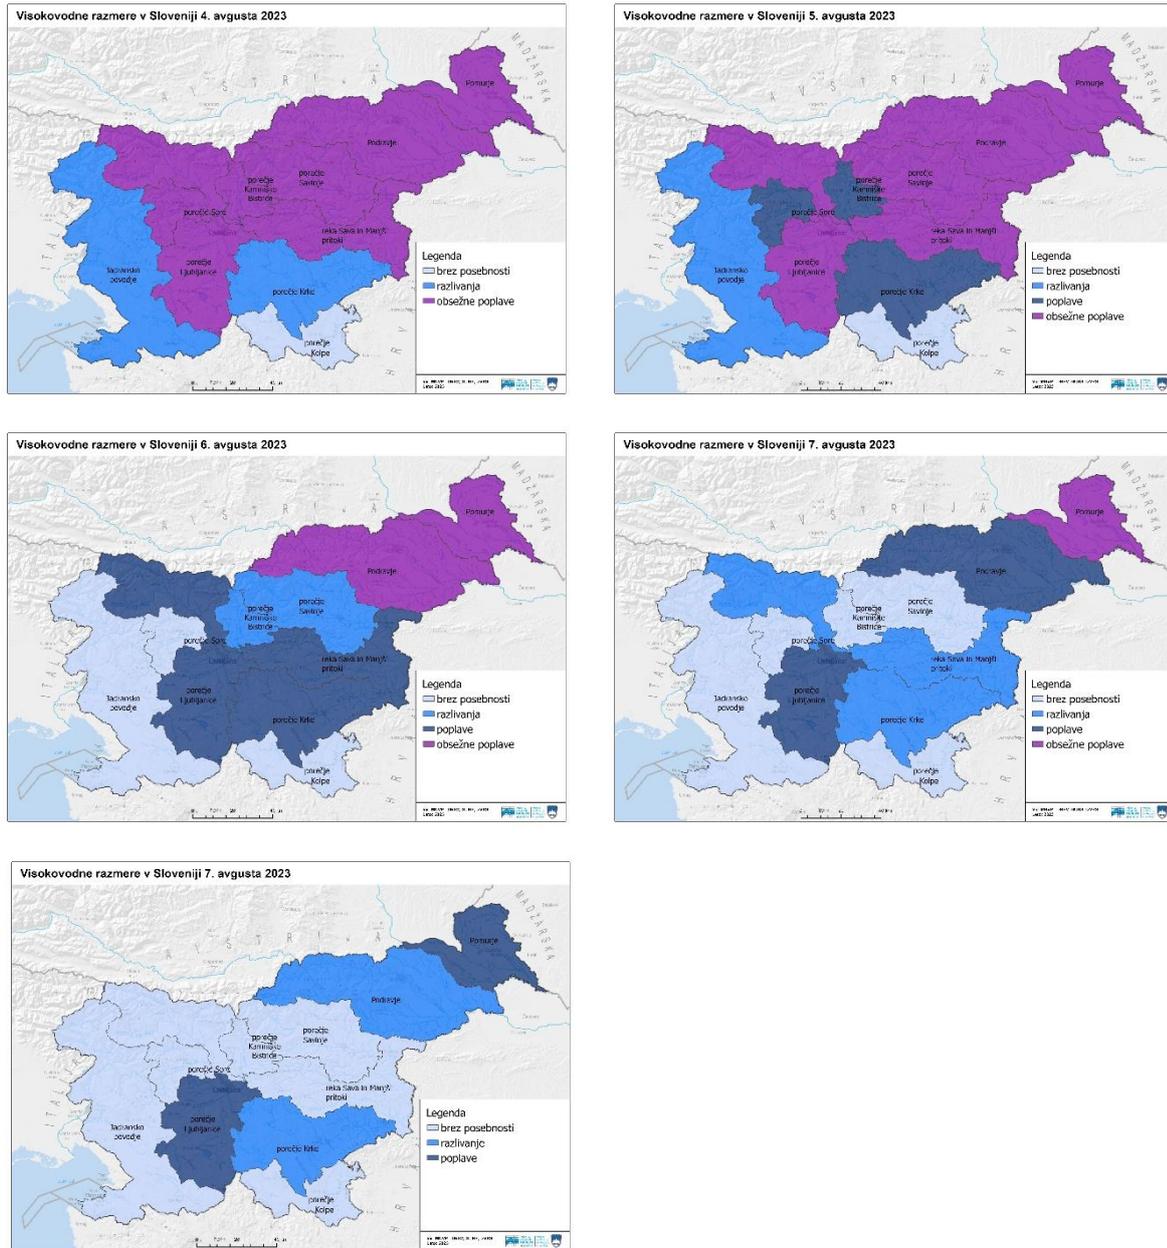
Figure 6: Overview of hydrological events in Slovenia from 04 August to 08 August 2023 (Legend: light blue – regular conditions, blue – overflowing, dark blue – flooding and violet - extensive flooding).

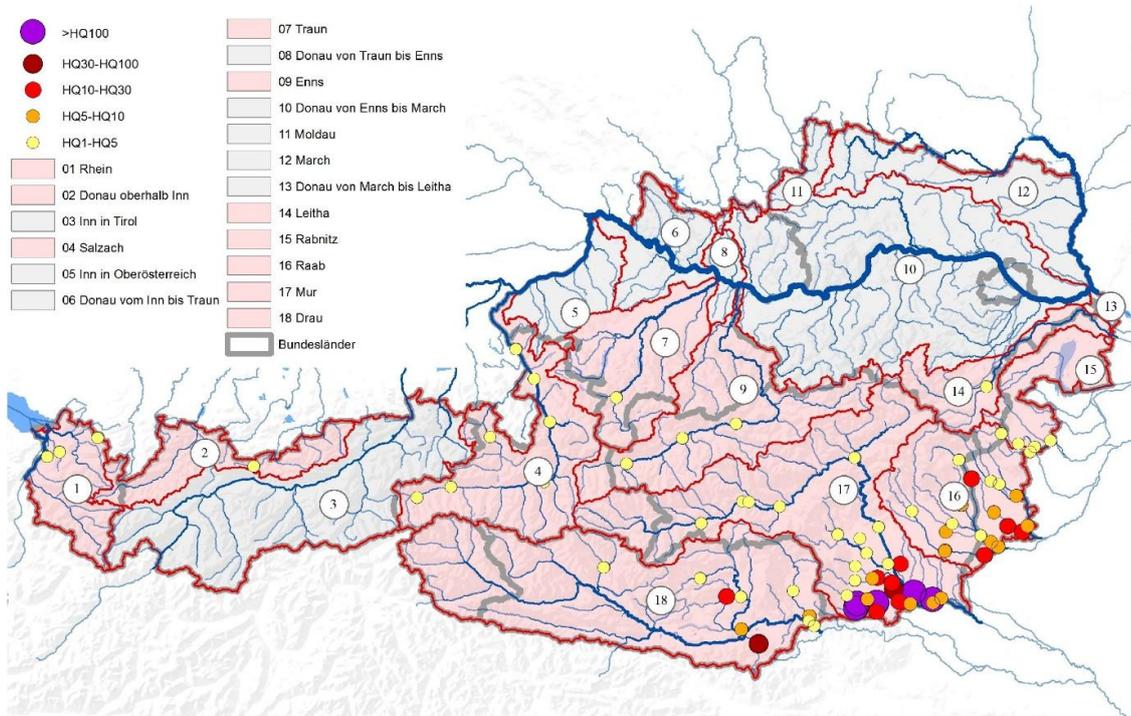
Figure 7: Overview of the recurrence intervals reached at the beginning of August 2023 at selected gauging stations, river basins (red = affected, gray = not affected) and federal states (gray lines). Data basis: Hydrography Austria - BMLUK.

The high levels of precipitation at the beginning of August in Austria followed a July that was generally very rainy in the south. The groundwater levels were therefore already at a high level at the beginning of August and the soil was saturated in many places. Floods therefore occurred mainly in Carinthia, southern Styria and southern Burgenland (Figure 7), with rivers overflowing their banks in many places.

In Carinthia, flood peaks in the range of a 30-year event (HQ30) and above were reached at the Drau tributaries in the lower Drau river basin. The Vellach recorded the highest value at the Miklauzhof gauge with a flow between a 30-year and a 100-year flood, followed by the Glan at the St. Veit gauge with an annuality between 10 and 30 years.

In Styria, the 100-year flood (HQ100) was exceeded at several gauging stations: Gündorf/Saggaubach, Hörnsdorf/Saggaubach, Wies/Weiße Sulm and Lipsch/Schwarzaubach.

In Burgenland, peak discharges of between a 10-year and a 30-year event (HQ10 to HQ30) were recorded on the Strem and Raab rivers. In the other federal states, the highest flows were between a 1-year and a 5-year flood HQ1 to HQ5.

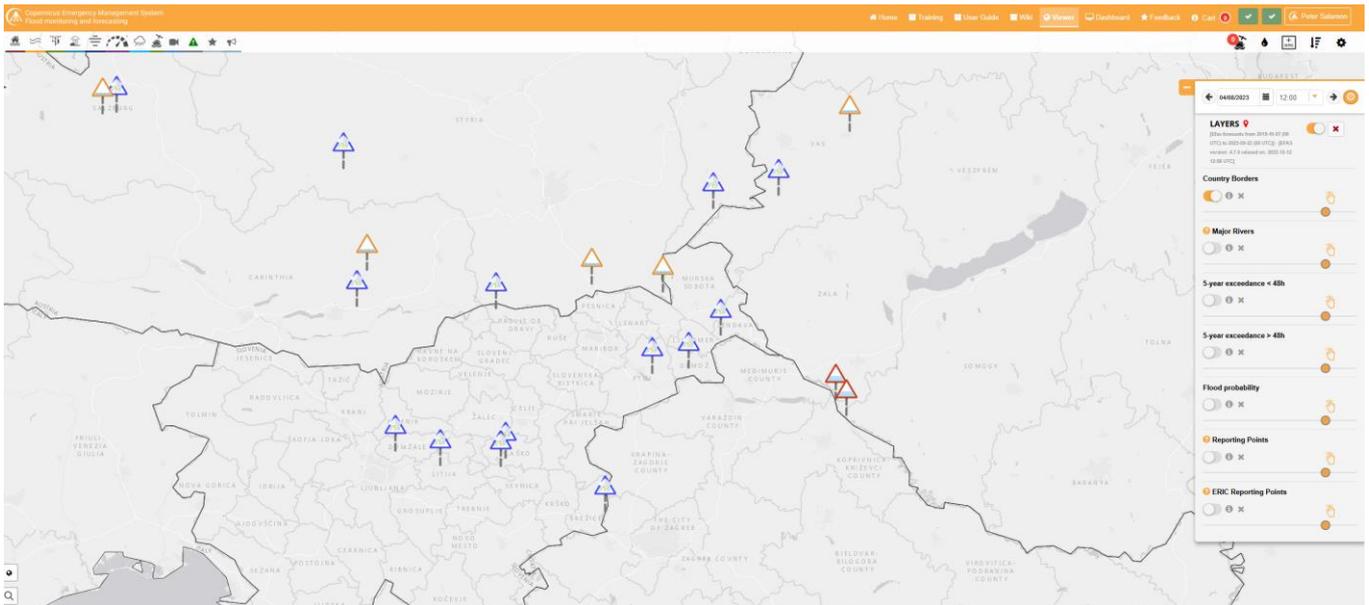
Figure 25 Active EFAS notifications for the forecast 04-08-2023 12UTC

EFAS provided a first informal flood notification for a high risk of flooding starting around 4-5 August in the Drava/Drau river (Austrian part) on 1 August 2023 to the relevant authorities in Austria and Slovenia. Subsequently, further formal/informal notifications were sent for the Mur River (Austrian part as well as Slovenian part), Drava River, and Saalach (Austria). EFAS flash flood notifications were sent for the Slovenia regions Osrednjeslovenska, Zasavska, Posavska, Savinjska, Koroska, Podravska, Pomurska and for the Austrian regions Salzburg, Steiermark, Kaernten and Burgenland. An overview of the active EFAS notifications for the forecast from 4 August 2023 12UTC is shown in the Figure below. It should be noted that this event was predicted with EFAS v4.8 which used still a spatial resolution for the hydrological model of 5km. EFAS v5.0 was released on 20 September 2023 which increased the spatial resolution of the hydrological model to ~1.5km and included also a new model calibration.

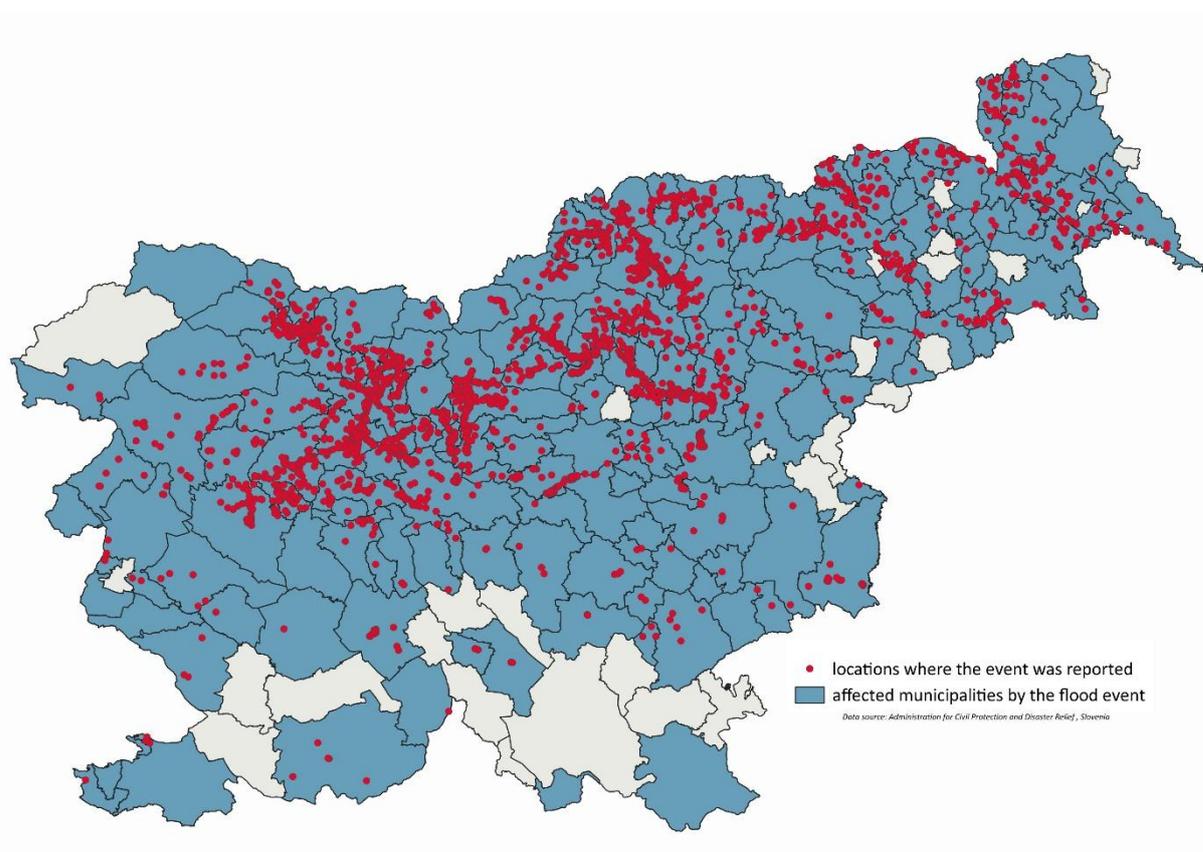
Figure 26: Map of municipalities where material damage or problems due to heavy rainfall and intense downpours were reported from 3 to 6 August. Data source: Administration of the Republic of Slovenia for Civil Protection and Disaster Relief, Information System for Reporting Interventions and Disasters.

The floods that hit Slovenia in August 2023 are considered the worst natural disaster in the country's history, causing devastating consequences for approximately two-thirds of its territory. As a result of the event, 171 municipalities or 12 regions were affected.

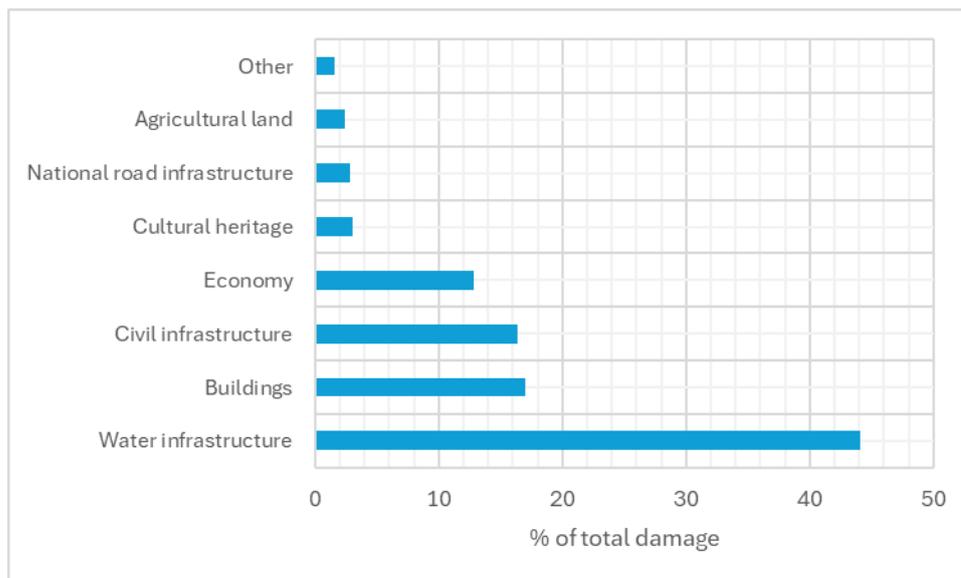
Figure 27: The distribution (by percentage) of the assessed damage to property by groups of claims in Slovenia

The Government of the Republic of Slovenia has approved the final assessment of damage to property due to the consequences of heavy rain, severe flooding, and landslides on 4 August 2023. The total amount is 2.999.802.159,20 euros.
