Floods in June 2013 in the Danube River Basin

Brief overview of key events and lessons learned

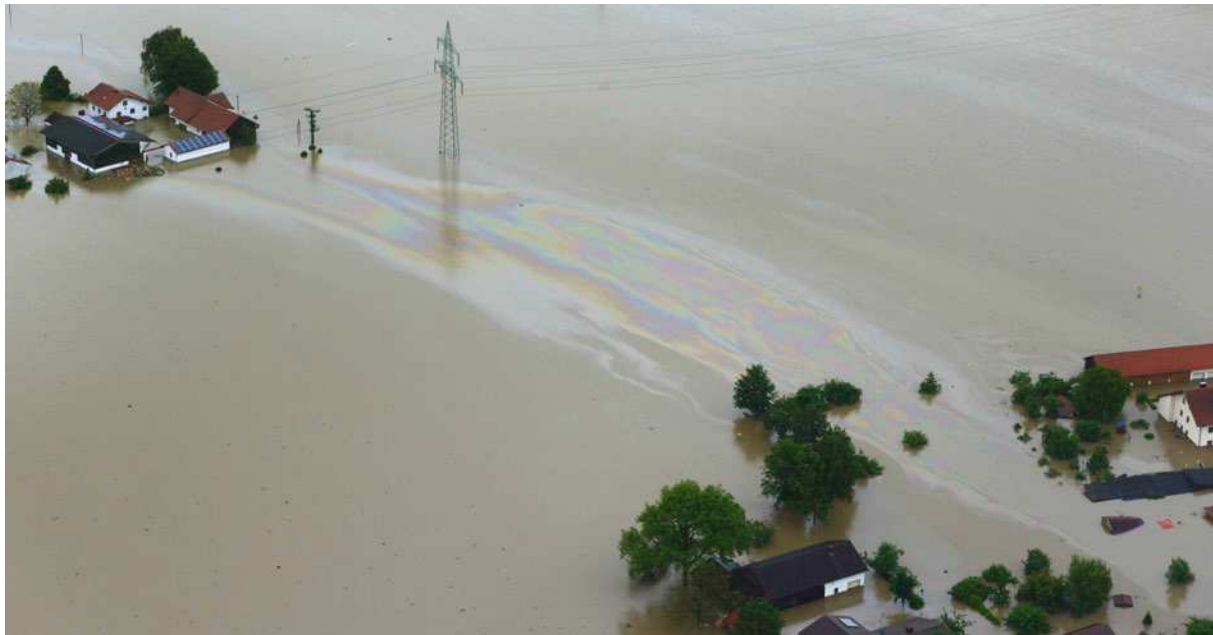
Figure 12 Oil pollution caused by floods in Bavaria

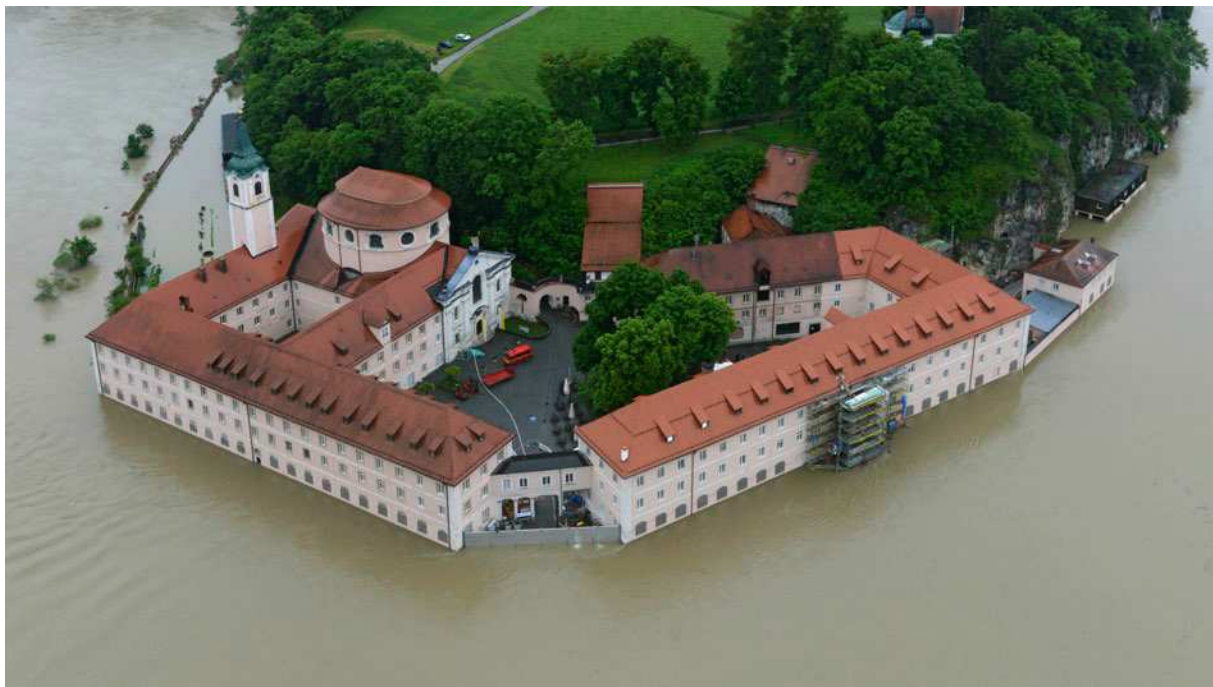
Figure 13 The castle in Weltenburg an der Donau protected by the mobile flood protection system

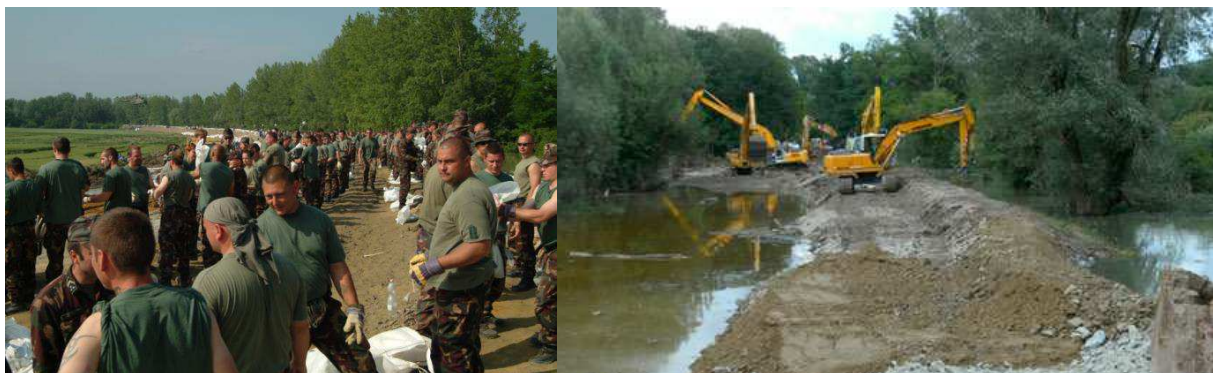
Figure 14 Dyke reinforcement at Győrújfalú

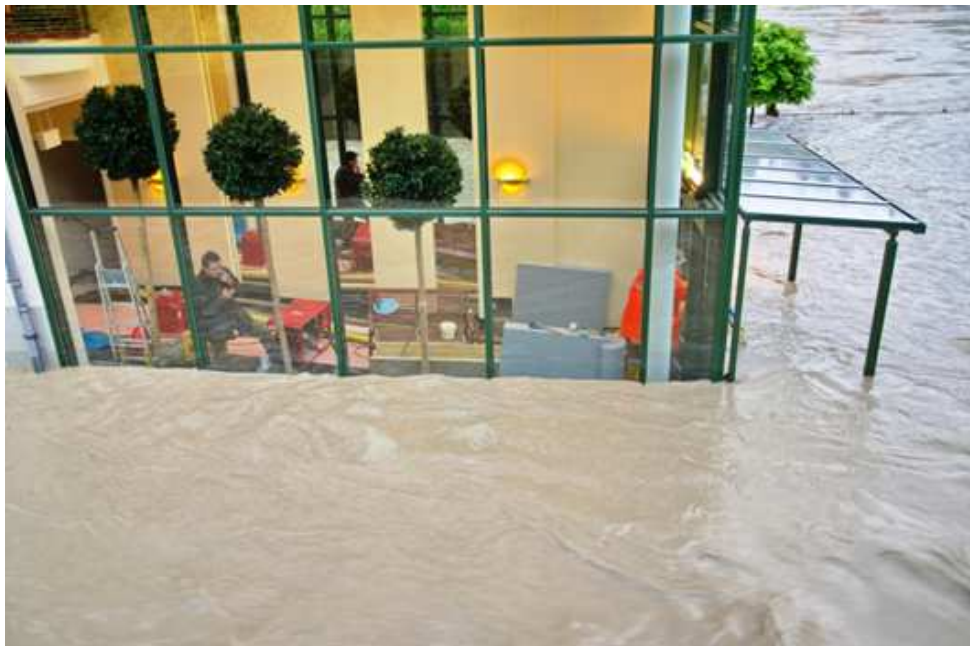
Figure 15 Building adapted to a flood risk in Austria
