DEMONSTRATION PROJECT

Selected Measures Towards Integrated Land and Water Management in Upper Tisza, Ukraine

VELYKY BYCHKIV (UKRAINE) – BOCICIOU-MARE (ROMANIA)

FINAL REPORT

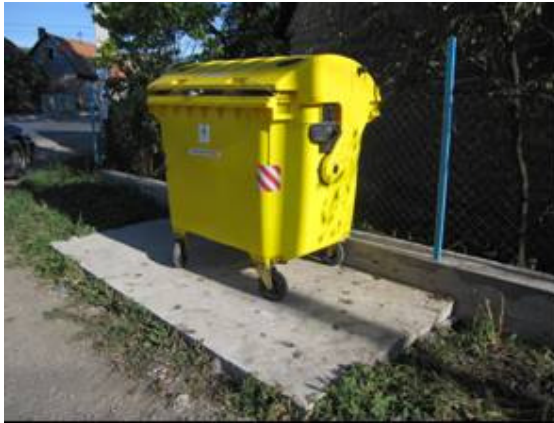
Installed container for plastic with platform

- 20 containers (1100 l) for PET bottles (installed at the central streets)
- 31 containers (240 l) for PET bottles for cafes, shops, restaurants, which mainly use PET bottles.

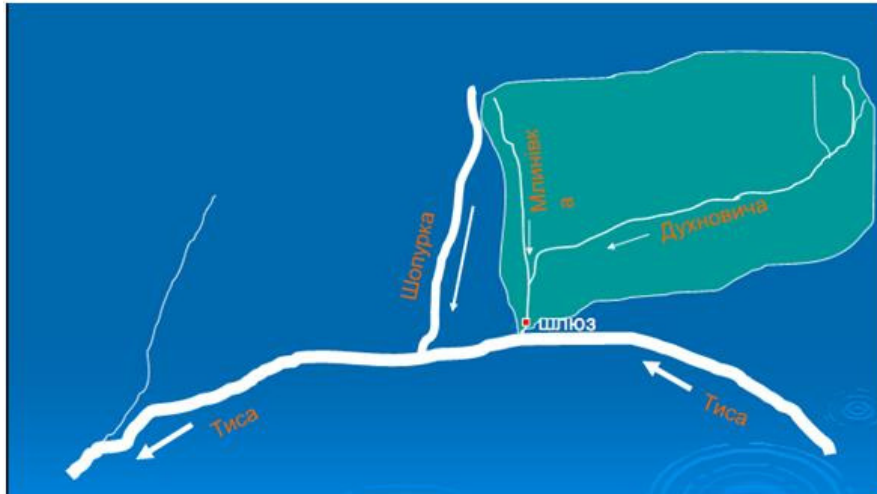
Mlynivka and Duhnovicha river network and the sluice to Tisza

Local hydrographic network within eastern part of Velyky Bychkiv includes two streams of length 2-3 km each: Mlynivka and nameless stream flowing along Duhnovicha street (further Duhnovich stream). Two of them merge just 100 m from Tisza and flow under the road and through a newly built sluice (2008) in the dike along Tisza. Construction of the sluice allows avoiding backwaters from Tisza when water level in Tisza is higher than in local streams. Nevertheless, it doesn't solve the problem for all cases. As an example, in the times of extreme high flood (historical flood for this stretch of Tisza) during July 2008, the sluice was closed and water from Tisza didn't flow into the village. However, runoff of the two streams was much bigger than volume of their beds and caused overflowing in the mouth relatively plain part of the catchment. As a result, 29 houses from 37 in whole village affected by flood (officially claimed for reimbursement) were damaged because of these small streams.

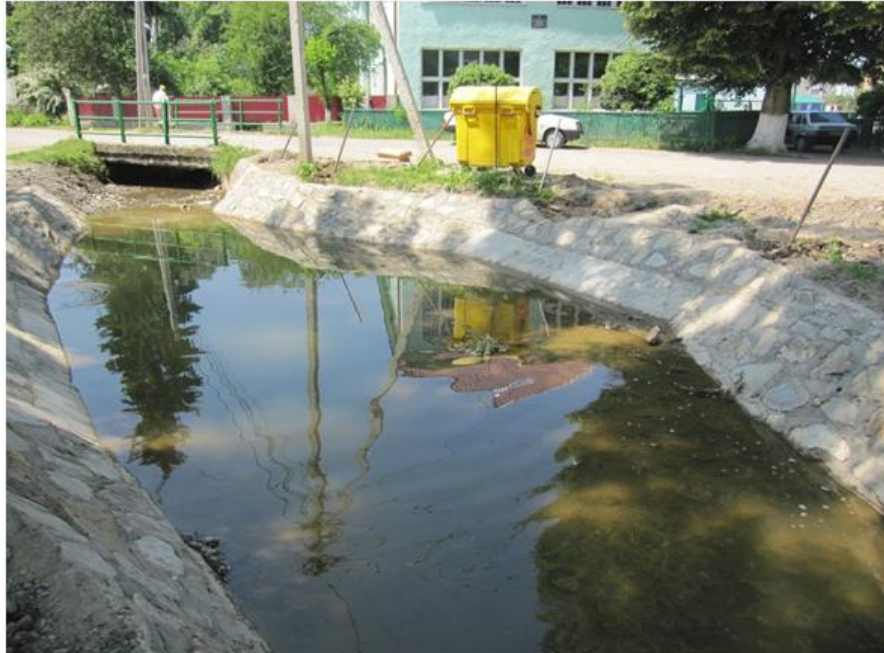
The main purpose of sediment catcher (1,5 m deep with inclined bottom) is to become a place for sediment collection to avoid their entering in the bottlenecks under the bridges and blocking the flow. As far as Dukhnovicha stream is mountainous it leads with it a large number of sediments. The catcher is very easy to clean.

The catcher is very positively assessed by the village. It showed efficient during floods in the end of 2010. The village council started to construct the similar things in other parts of the village, so the experience is replicated.

Sediment catcher before the first bridge in lowland part of the village

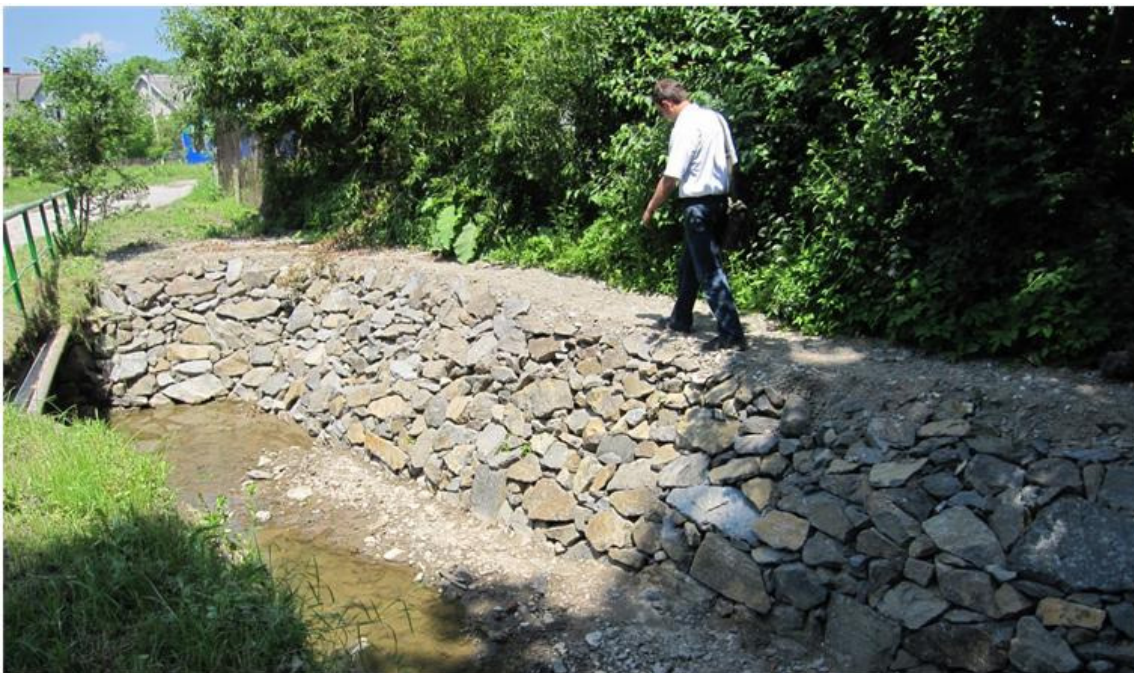
Another construction done with the support of the project is smoothing the angle of the stream near the school and construction of protection wall near the school # 1. This school often suffered during any floods due to waters striking against the angle near the bridge. Now the wall with flattened angle improved the situation.

Bank enforcement and angle smoothing

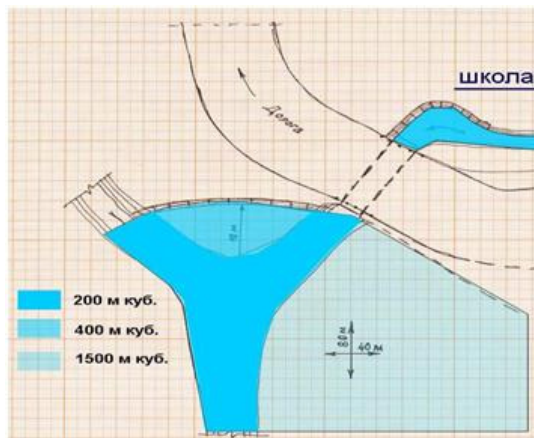
The polder of capacity 400 m³ was established in the place of jointing of Mlinivka and Duhnovicha stream. Although the capacity of the polder is quite small, it can retain floods waters of not very extreme floods and give additional time for water management services to install pumps to transfer water from Duhnovicha to Tisza.

Scheme of accumulation polder

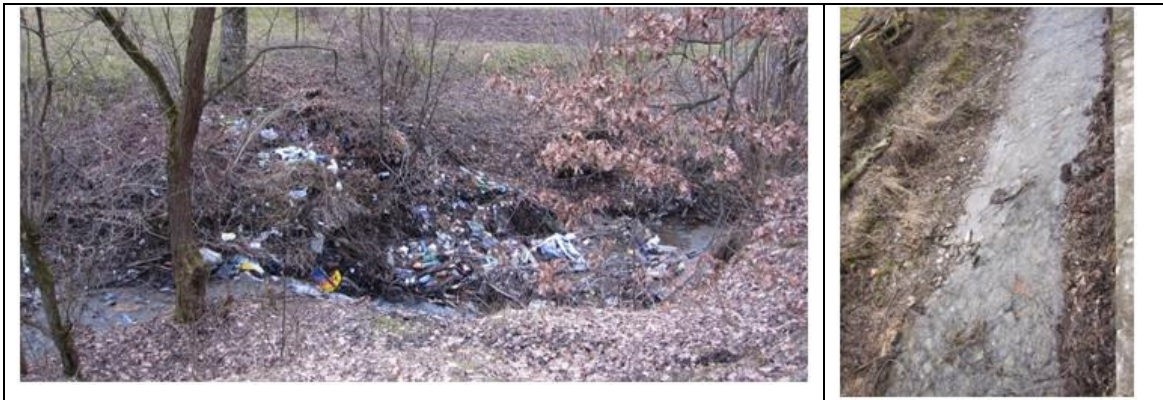
- cleaning of the upstream part of Duhnovicha stream from the waste (more than 15 trucks of garbage were collected)
- cleaned the spaces under the bridges, liquidating the bottom necks
- support in installation of the fence around sediment catcher.

Before

After

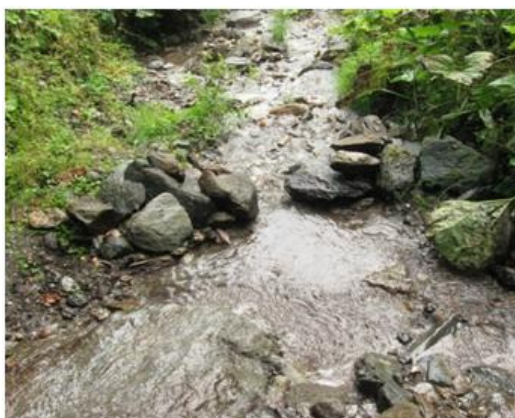
- creating of artificial cascades from local stone (not less than 3 cascades) and increase of sinuosity of the stream by creating of side inlets (not less than 3 side inlets)

Example of the artificial rapids

The second stage of renaturalization include restoration of morphological and biotopical structure of the river on the basis of earlier determined for this case proportion of bottom substrata areas (Afanasyev, 2006) and remainder of natural bends, rapids and hollows. Due to the fact that 8 dams, 7 half-dams and 5 artificial rapids were made of local stones, the riverbed tortuosity was restored, while drops of depths and zones with different stream speeds and turbulization were created. The works were done conducted by Dilove forestry under the guidance of Institute of Hydrobiology, following the developed methodology.
